TECHNICAL INSPECTION REPORT

OPERATION CROSSROADS. U.S.S. INDEPENDENCE (CVL 22)

TEST ABLE.

VOLUME 2 OF 4 [10]

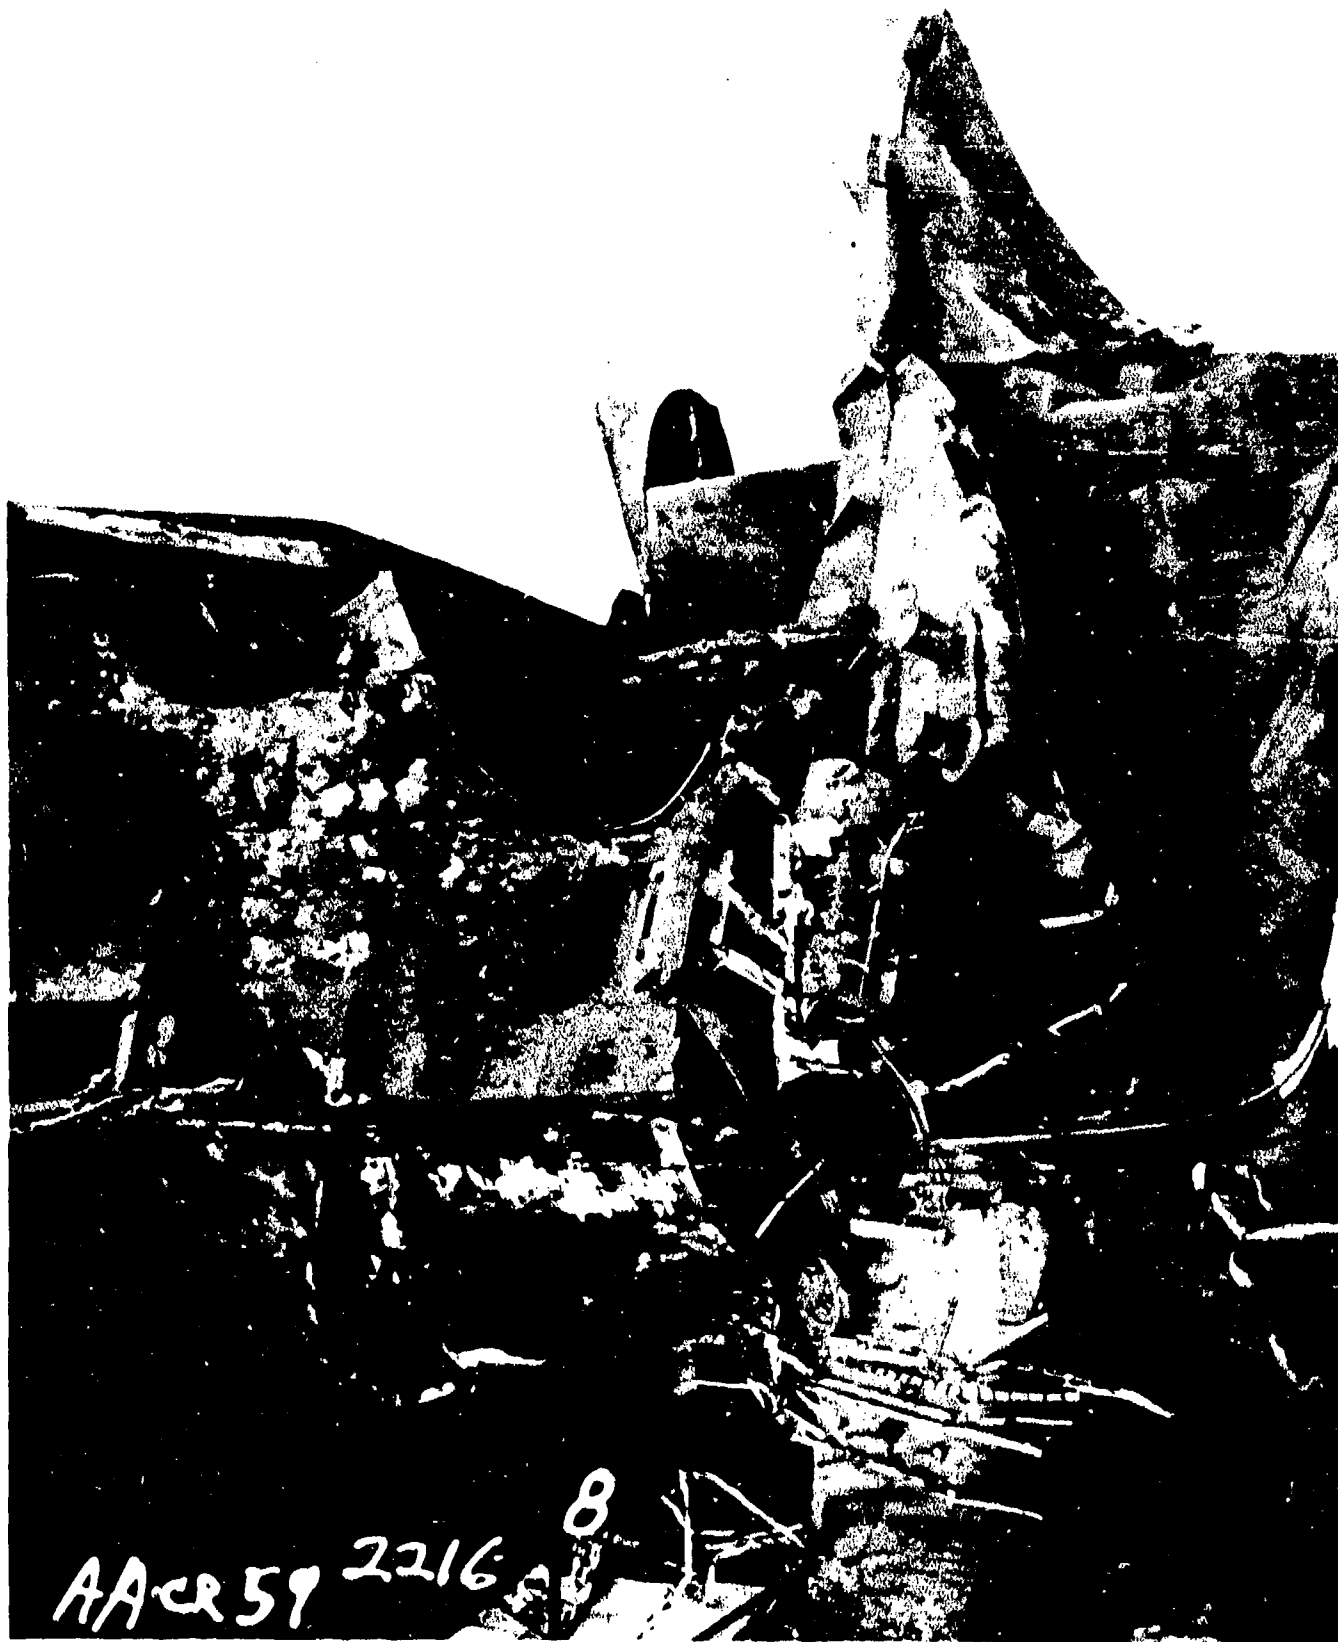
AA-CR-59-2216-8. Port side, aft of frame 140, above third deck level. Note tears at second and third deck levels, and splitting of shell below main deck at frame 145.

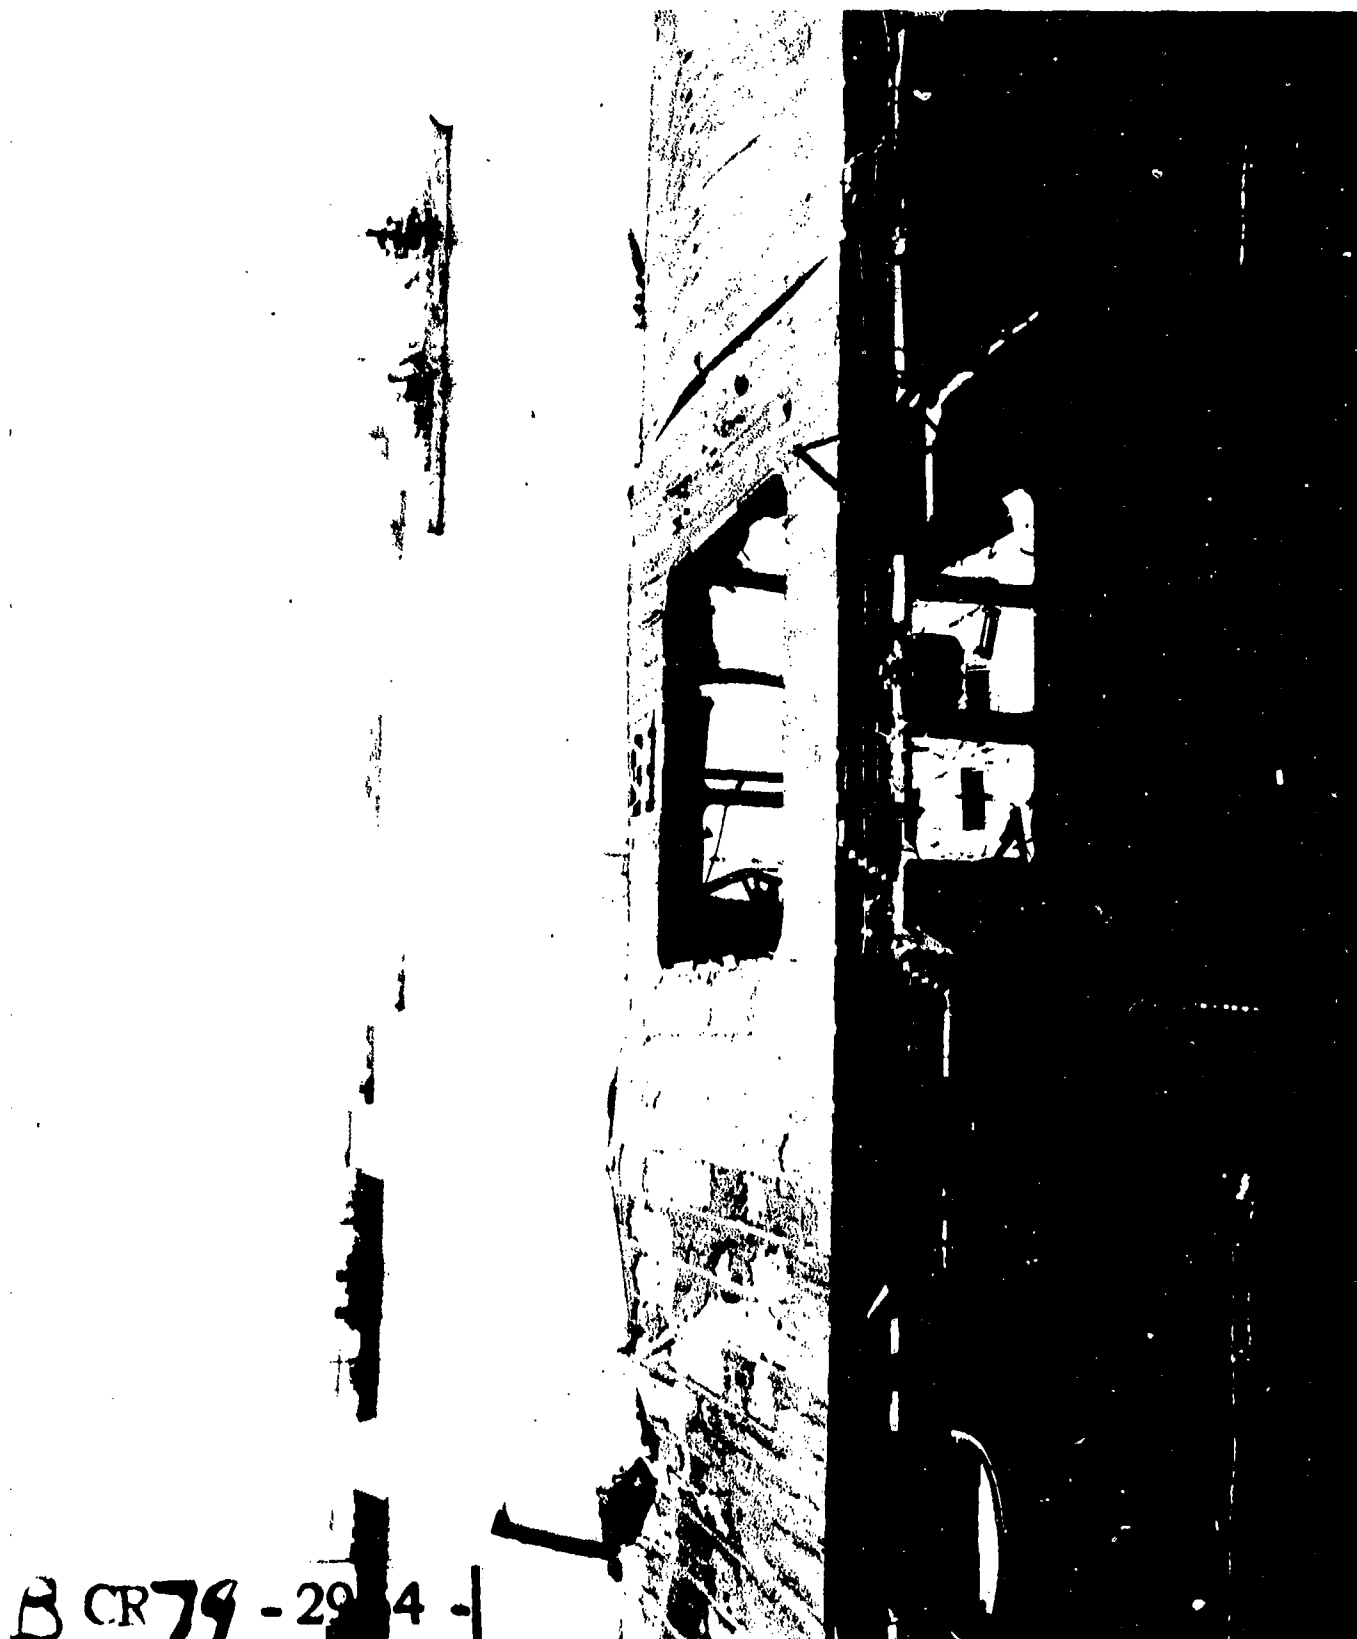
AB-CR-79-2964-2. Flight deck in way of after elevator, frames 110 to 150, looking down and to port from point off starboard side. Note effects of fire on deck aft of elevator well.

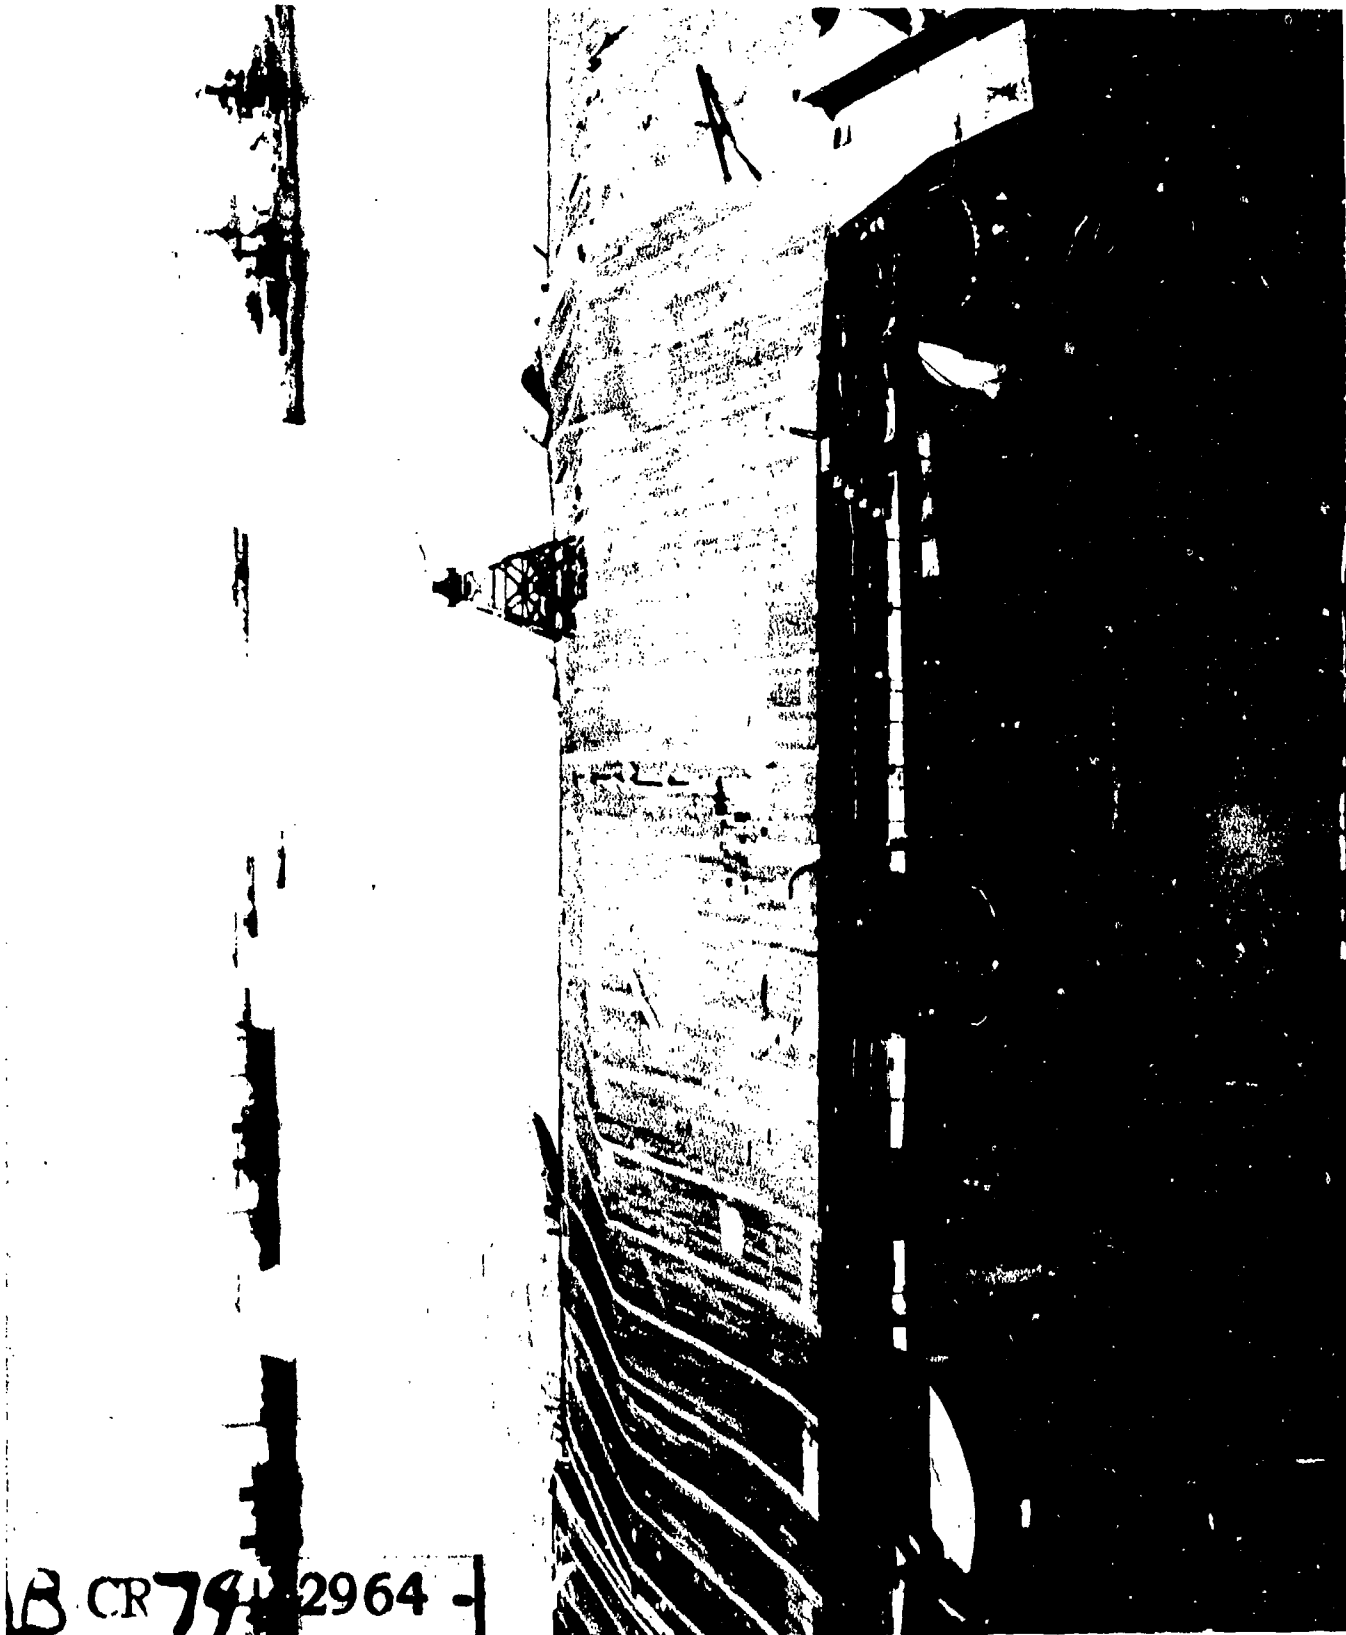
AB CR 79-2964 -

AB-CR-79-2964-4. Flight deck, frame 80 to 110, looking down and to port from point off starboard beam. Expansion joints in deck appears at right and left. The separation in the picture is a failure in the deck plating.

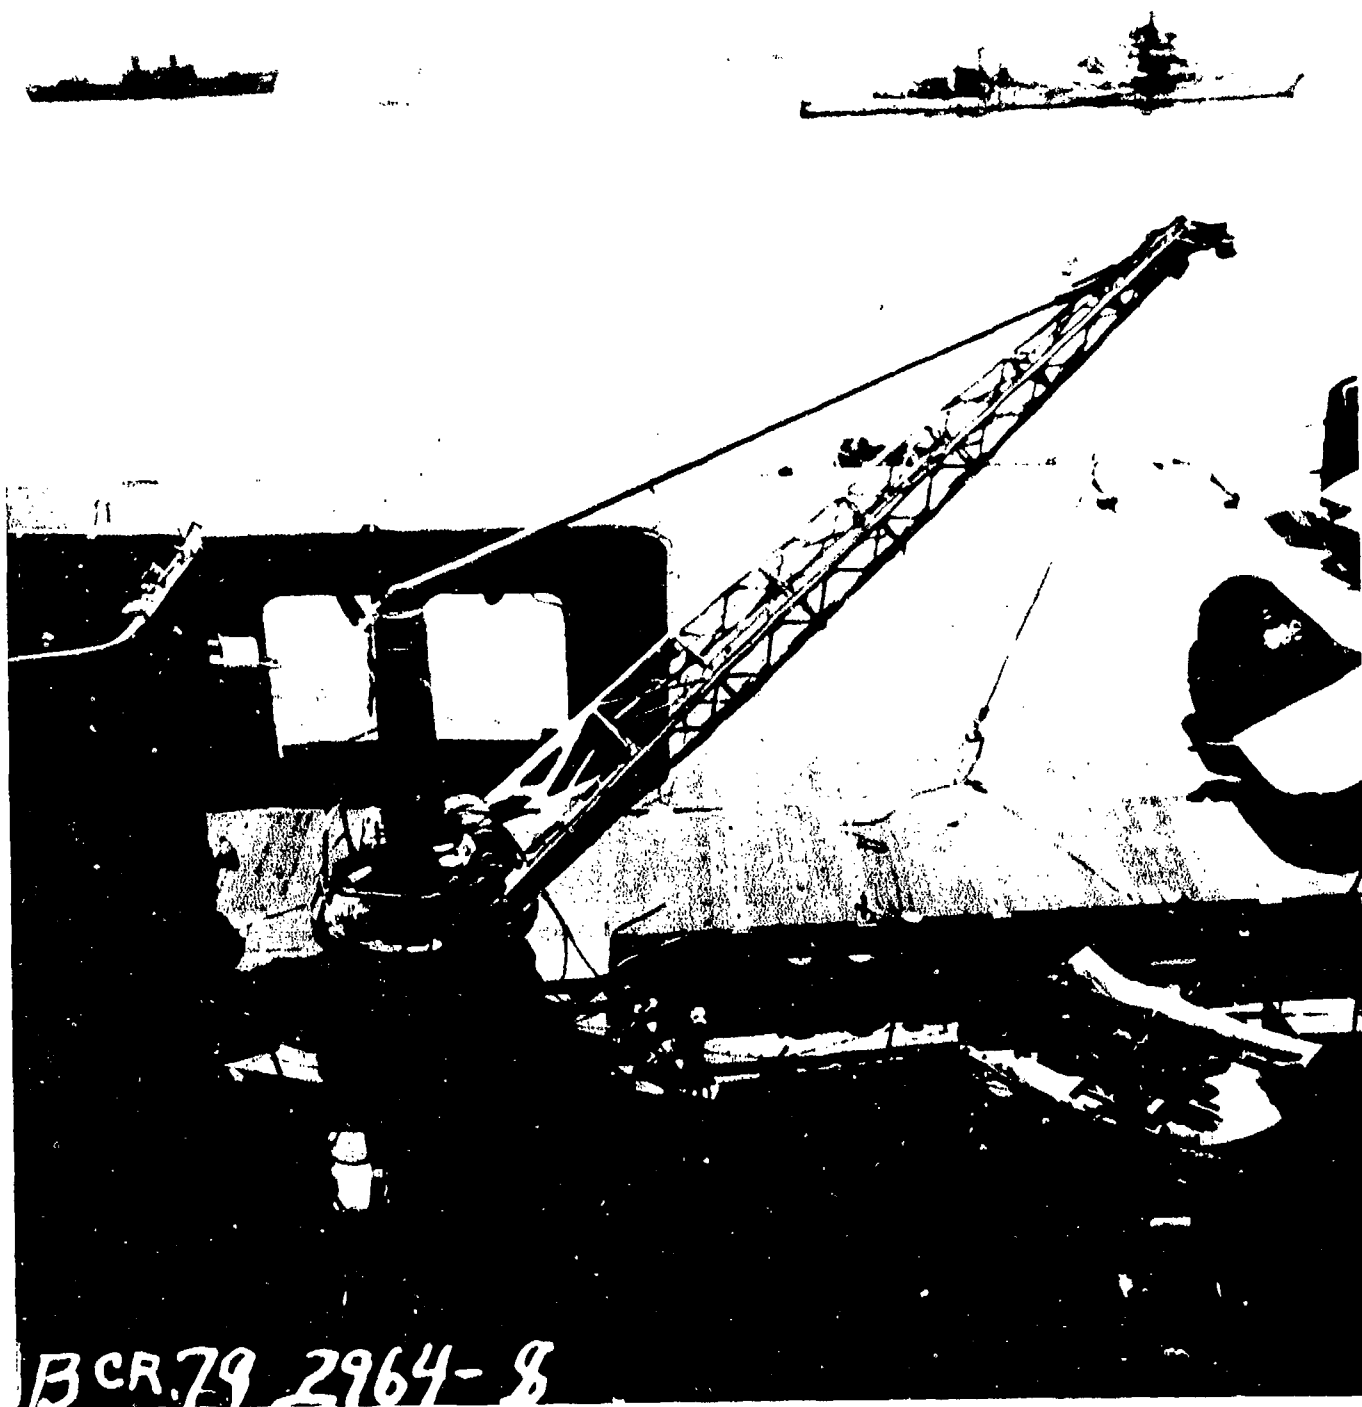
AB-CR-79-2964-8. Flight deck and forward face of island, frames 40 to 50, looking down and to port.

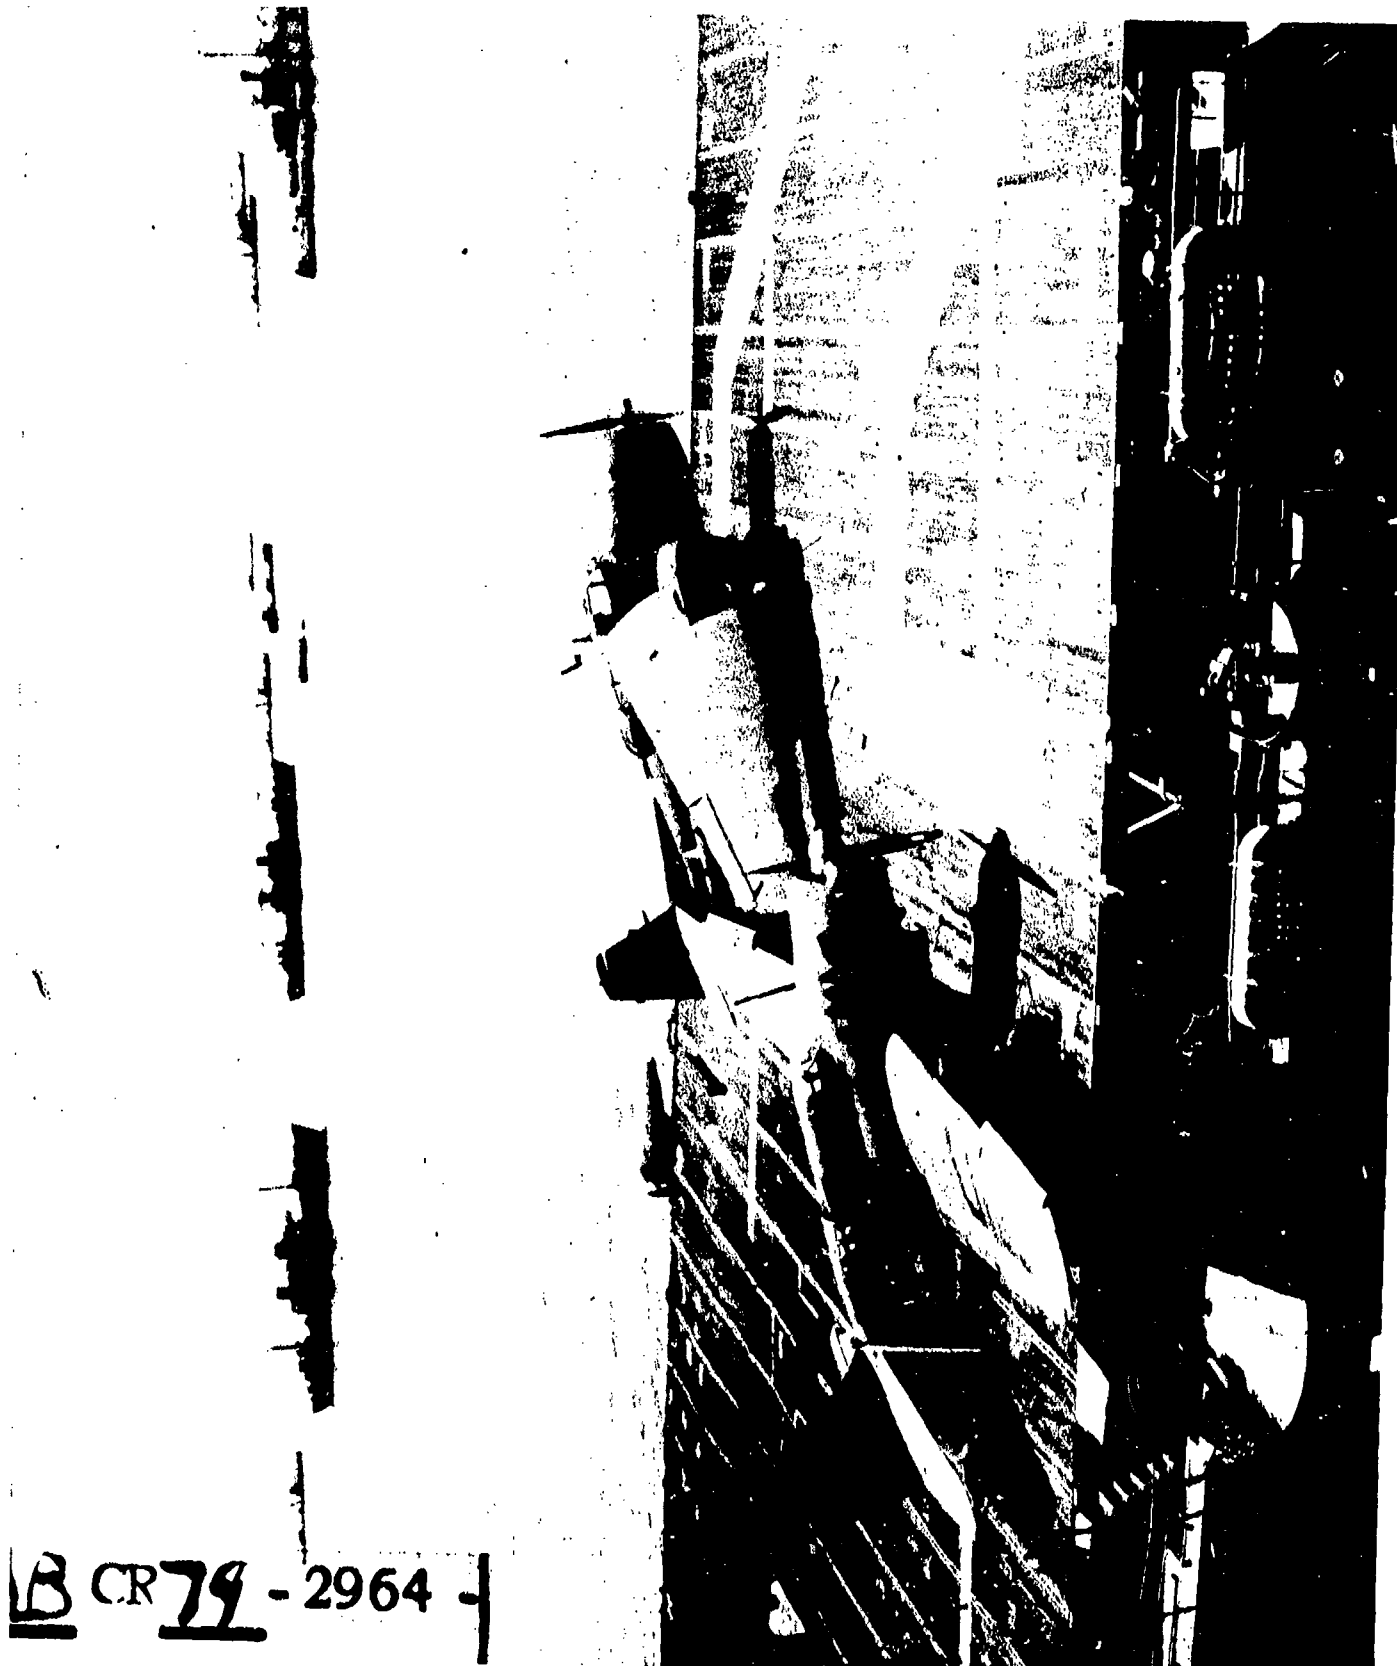
AB CR 79 - 2964 -

AB-CR-79-2964-11. Flight deck just forward of elevator shaft, frames 20 to 40, looking down and to port from starboard bow.

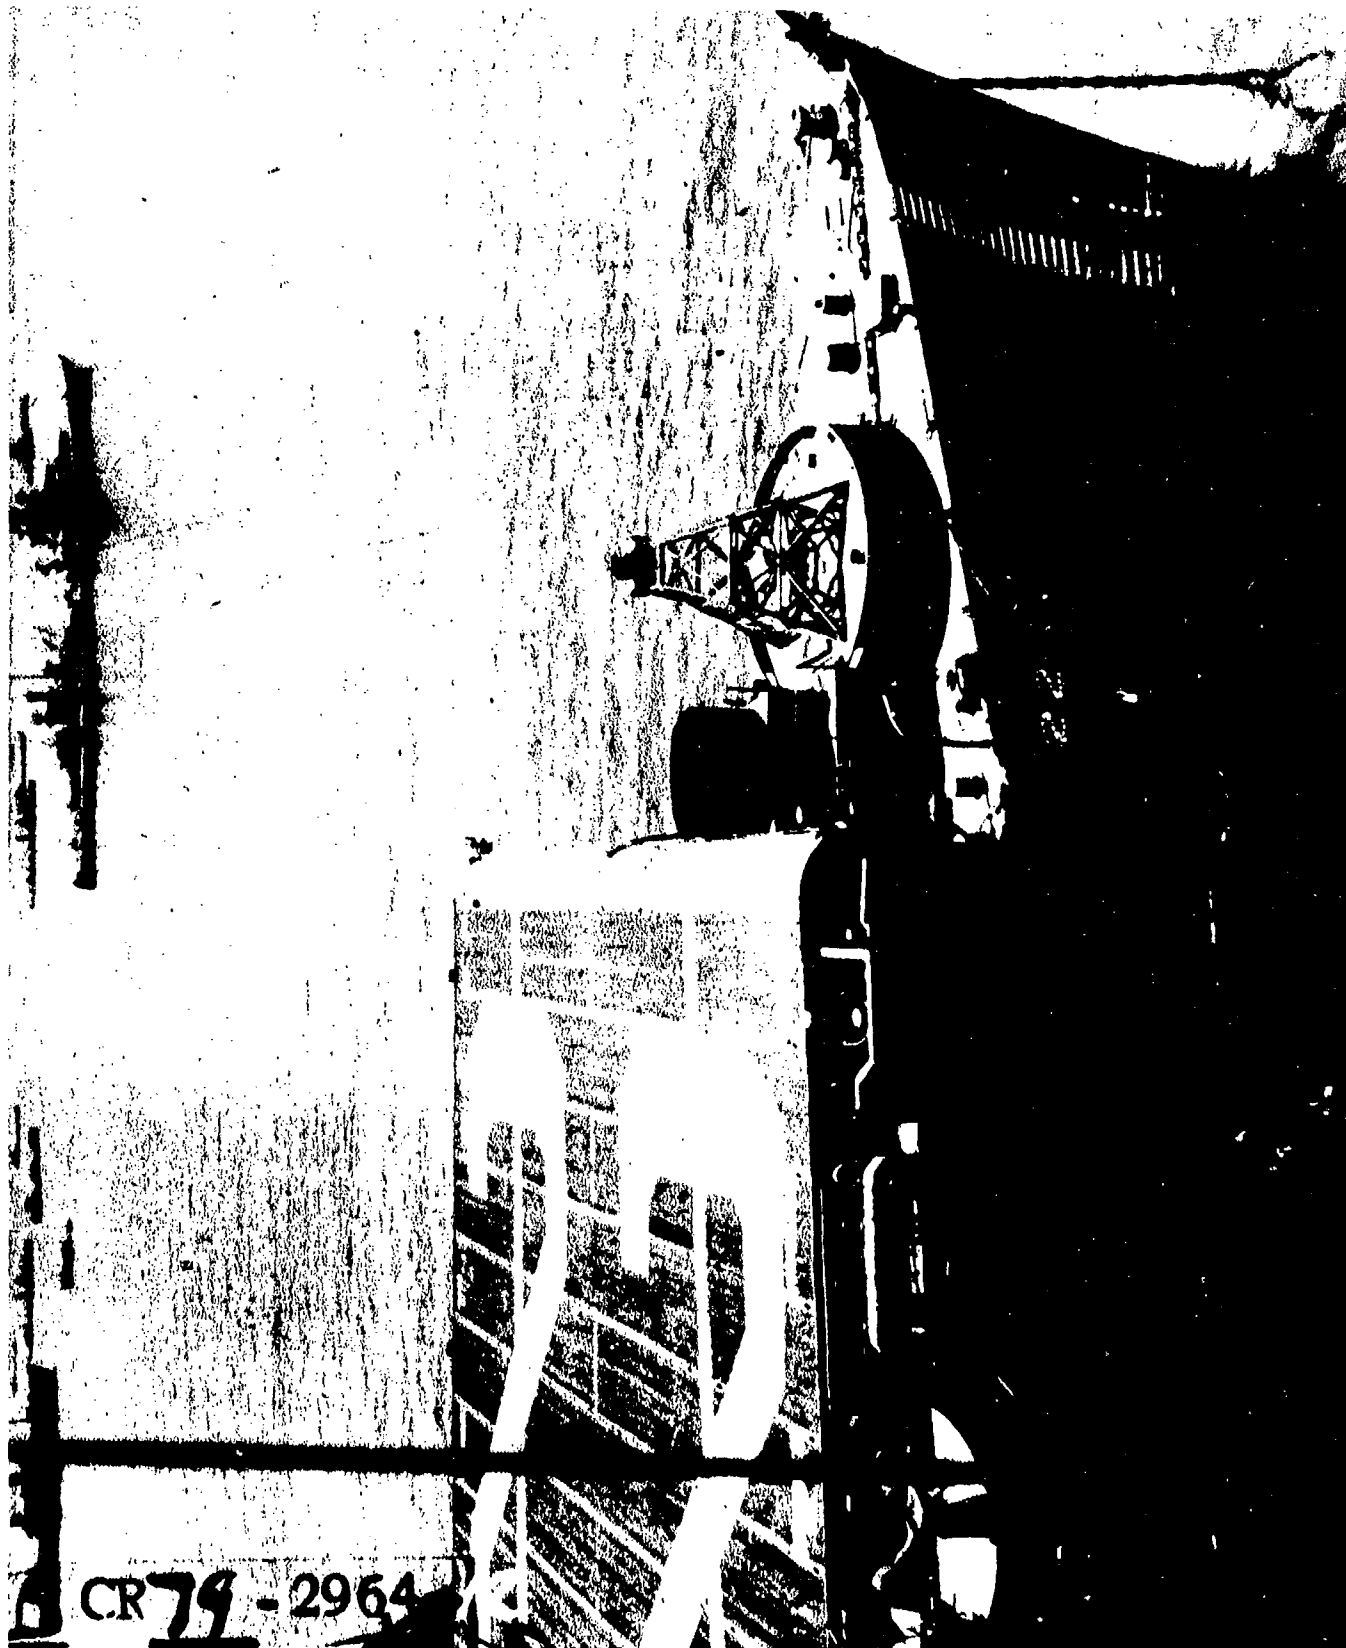
AB-CR-79-2964-12. Forward edge of flight deck and forecastle deck, looking down and to port from off starboard bow.

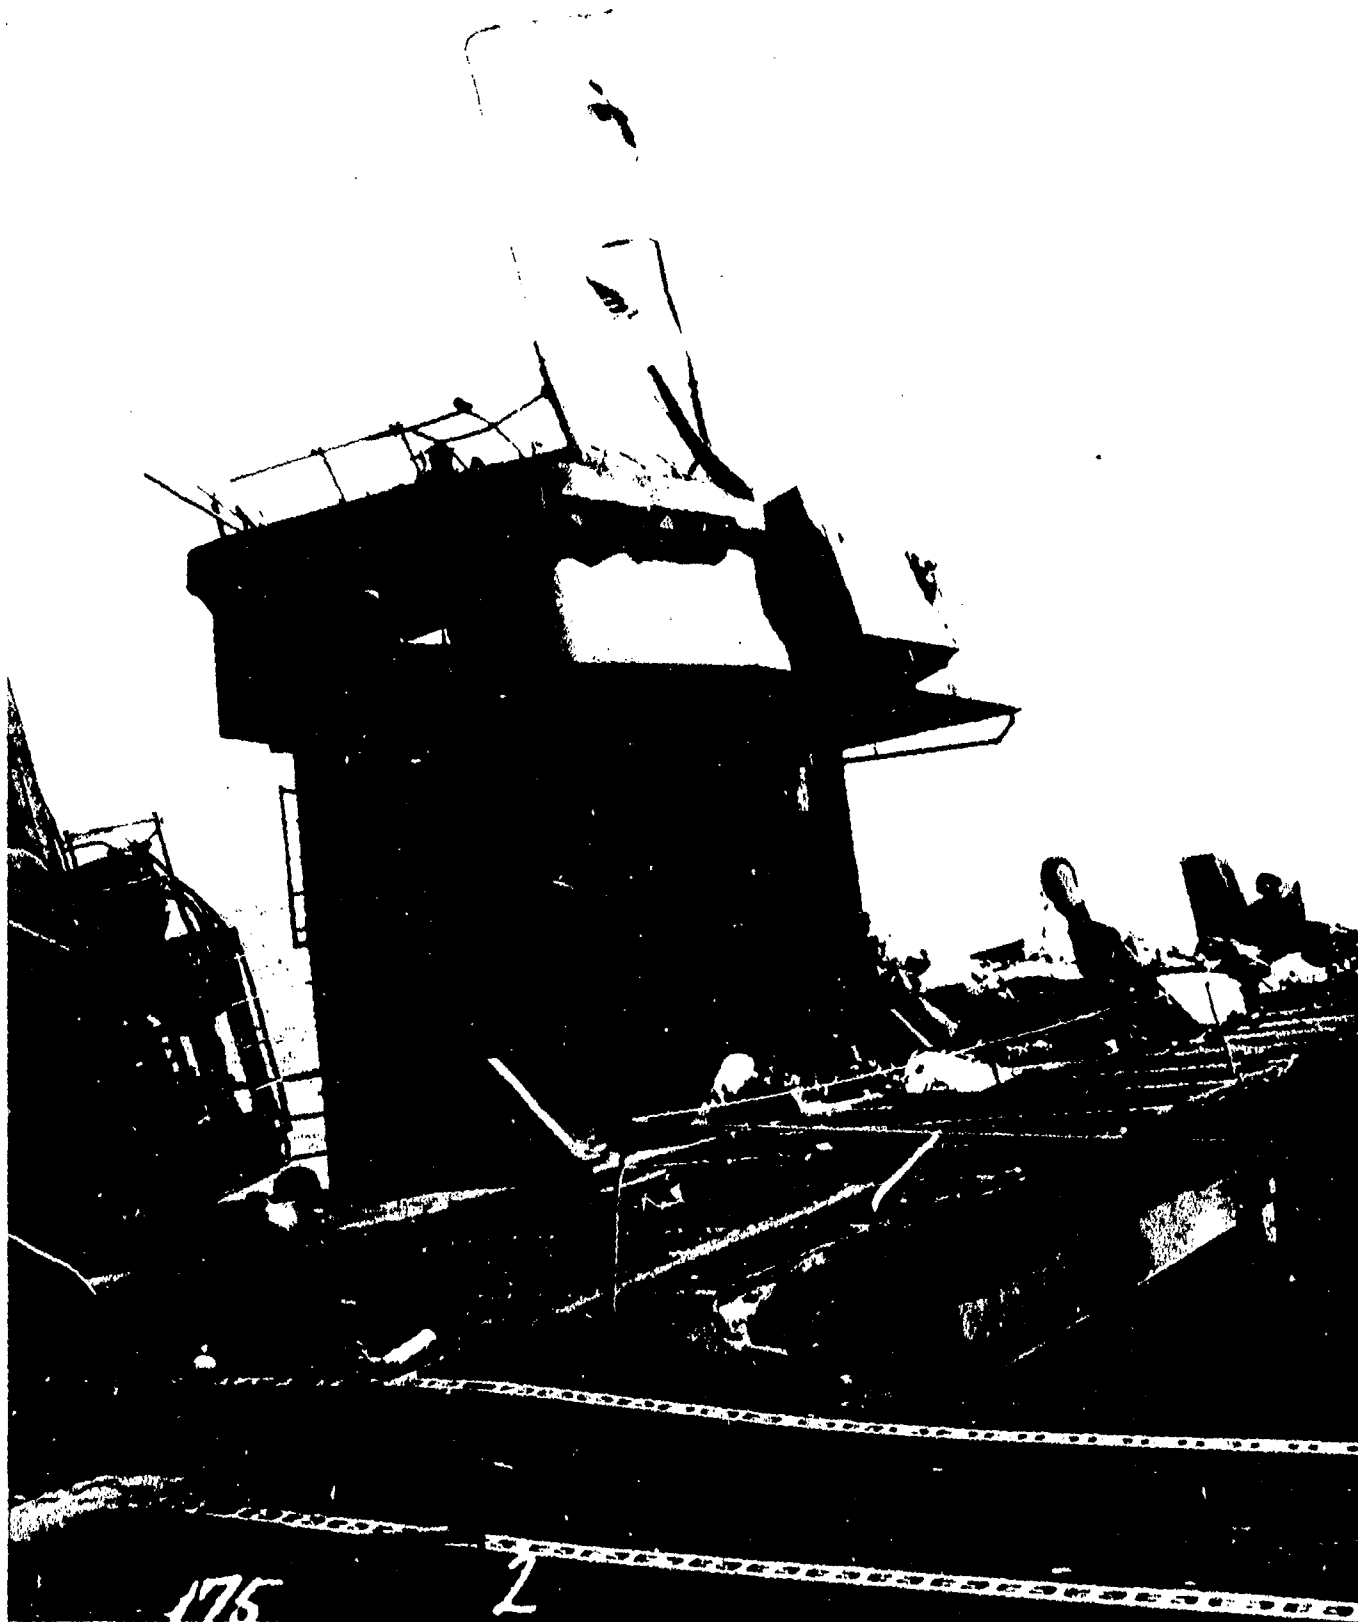
AA-CR-175-2039-2. Flight deck from frame 37, looking aft.

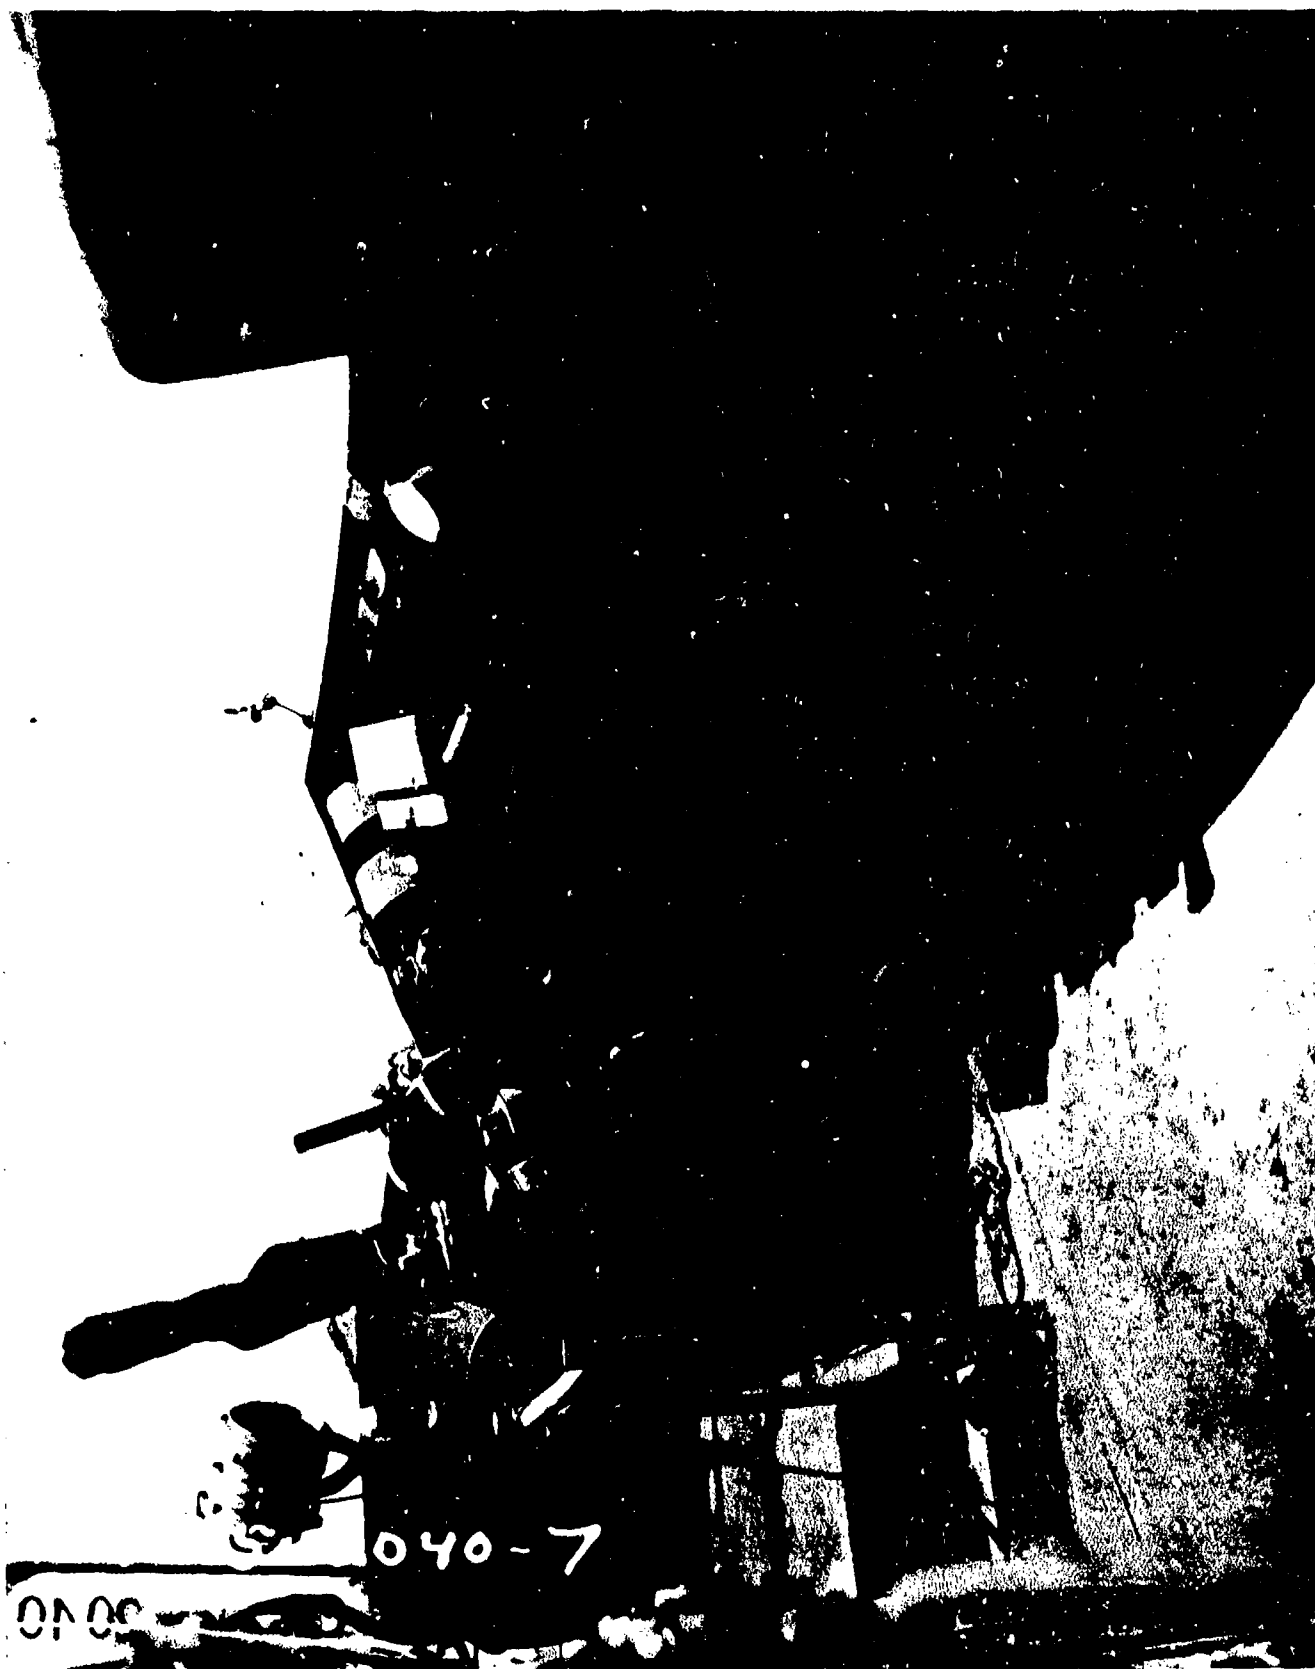
AA-CR-175-2040-7. Port air defense level, looking aft. Note raised out-board portion of deck and bulwark blown to starboard.

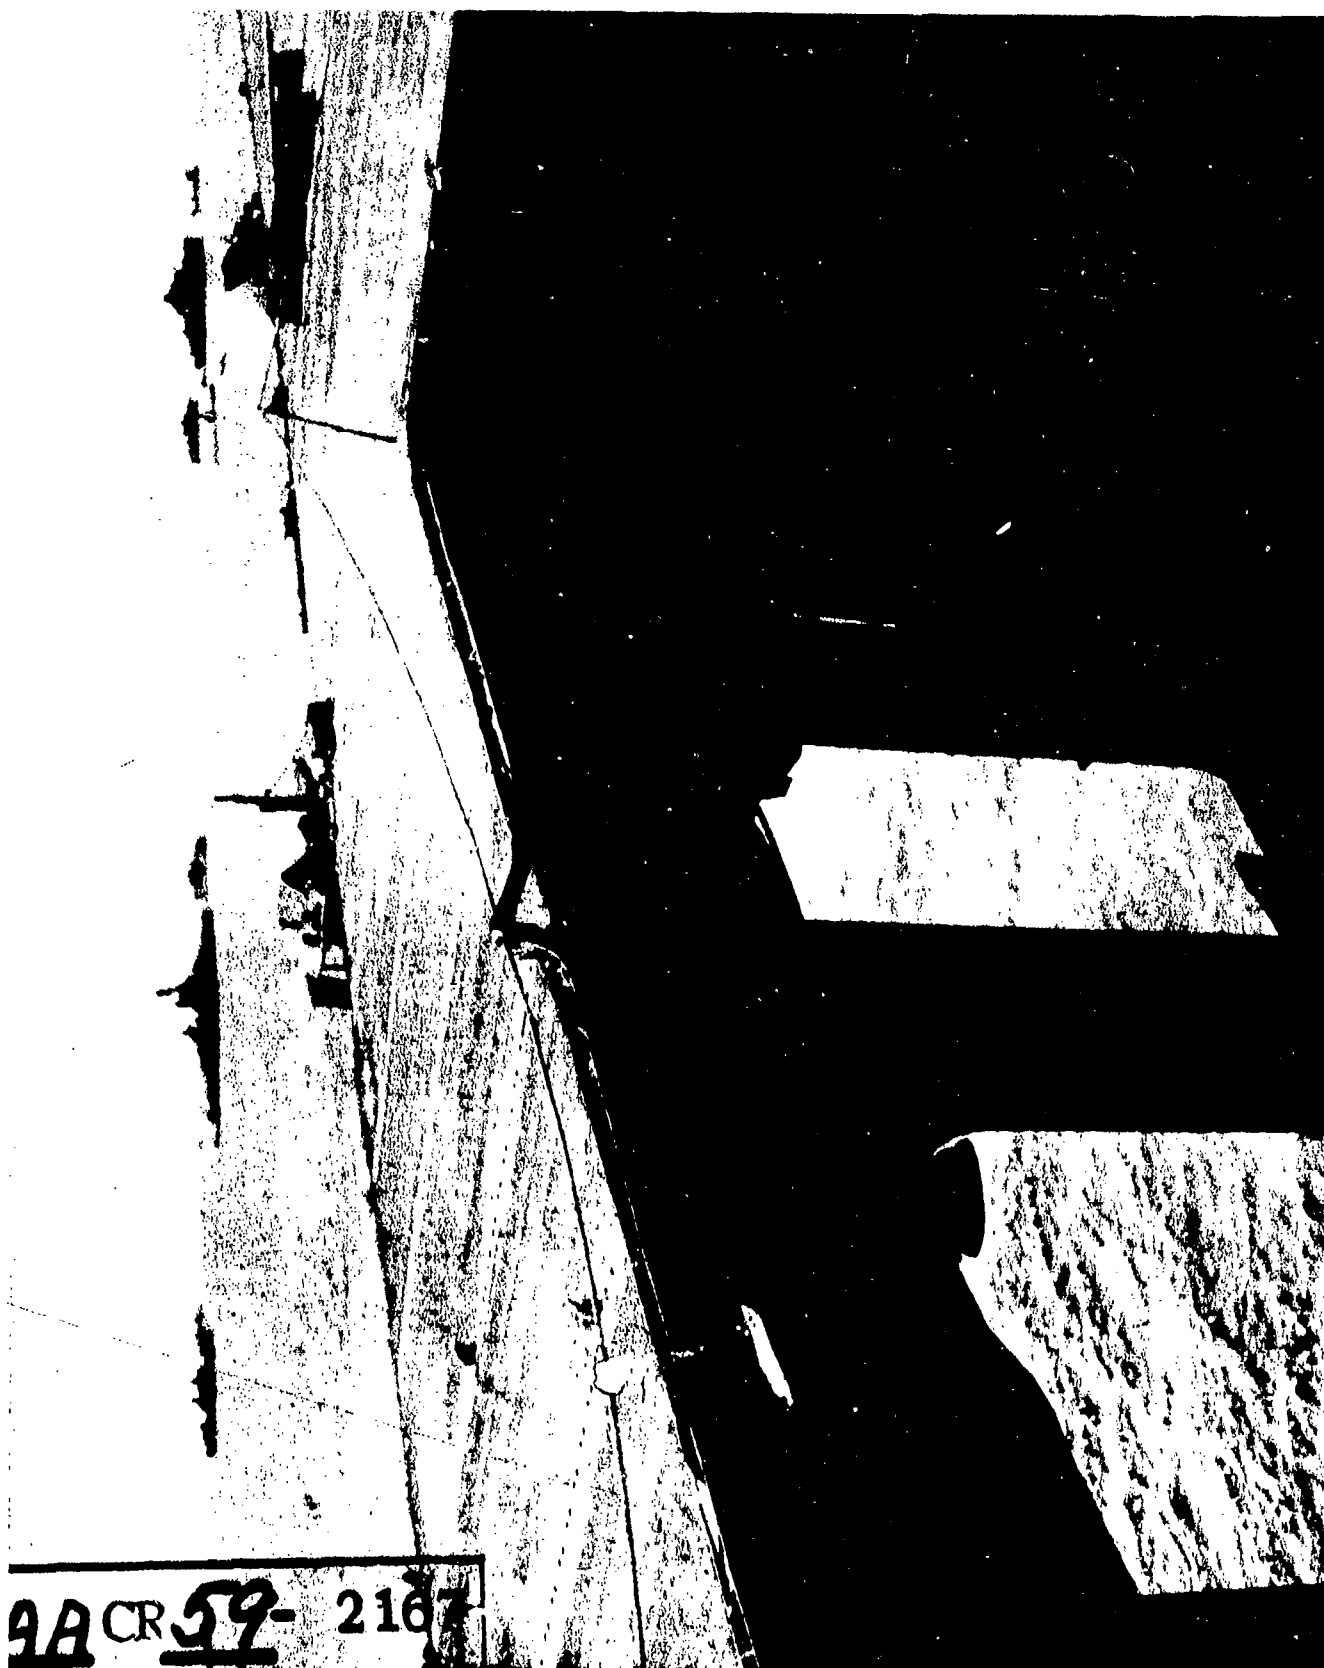
AA CR 59-2167

AA-CR-59-2167-9. Forward elevator opening. Port side. Waterway distorted and broken over elevator guide rail.

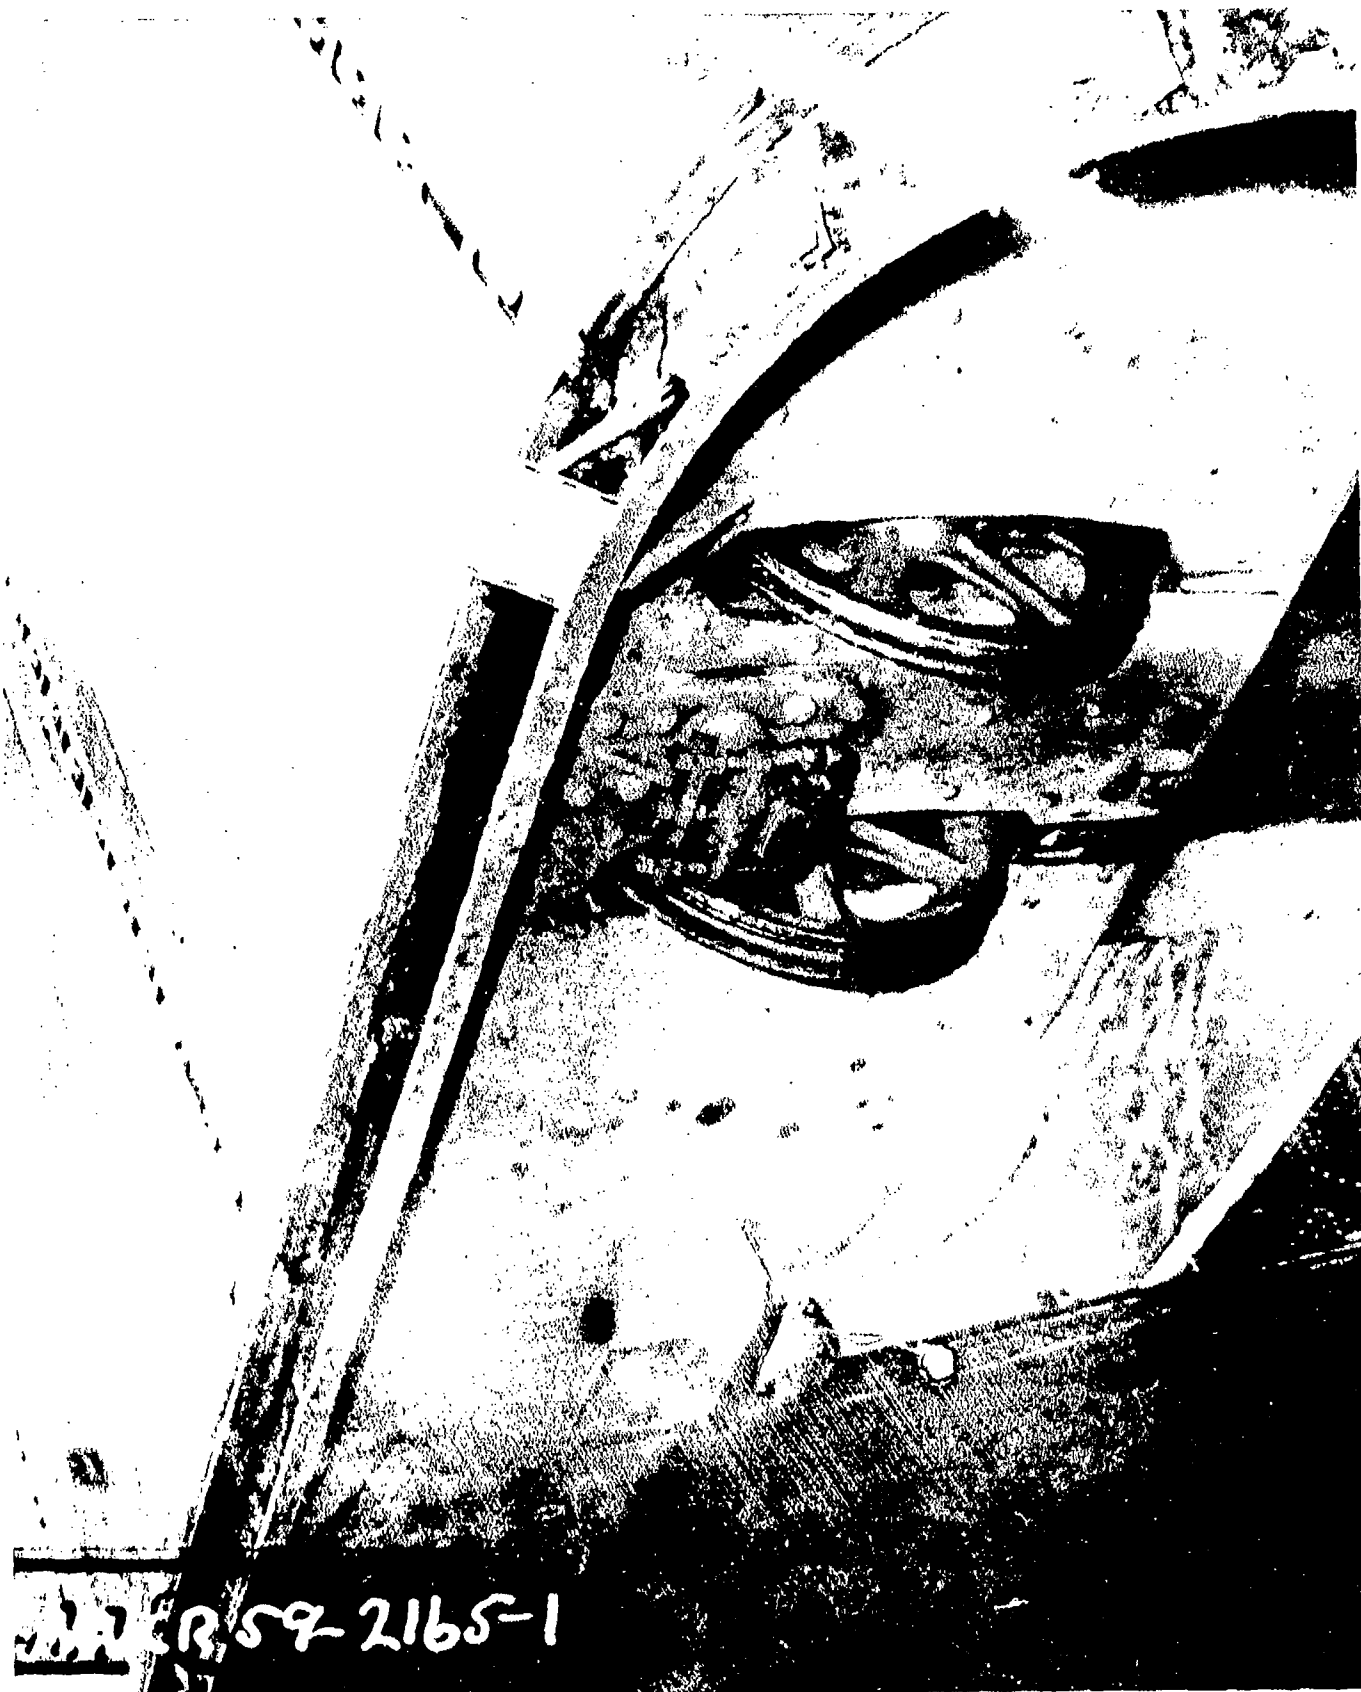
AA-CR-59-2165-1. Forward elevator. Forward, port, lock. Lock out 1", but not sheared; sheaves apparently undamaged. Safety latch bent outboard.
